REGIONAL WASTEWATER UTILITY RESPONSE AND RECOVERY FROM HURRICANE SANDY

OCEAN COUNTY UTILITIES AUTHORITY

Keith B. Marcoon, P.E.

The 2013 NJWEA Winter
Technology Transfer Seminar
March 4 - March 7, 2013

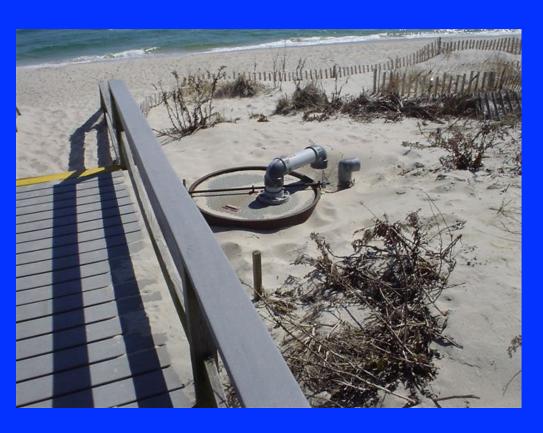
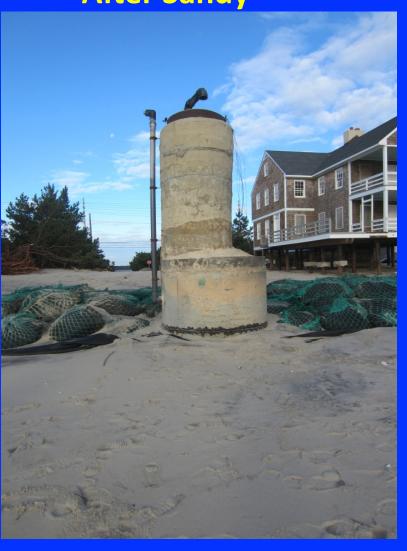
NWPCF Ocean Outfall Manhole, Mantoloking

Before Sandy

After Sandy

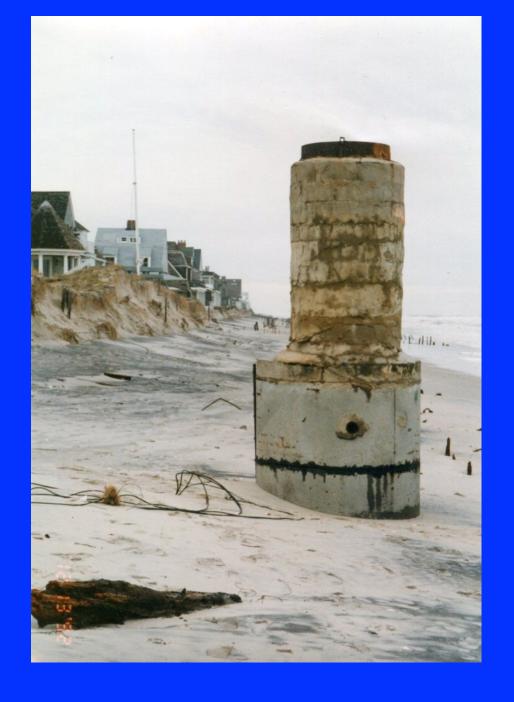
NWPCF Ocean Outfall Manhole, Mantoloking

December 13, 1992 Nor'easter

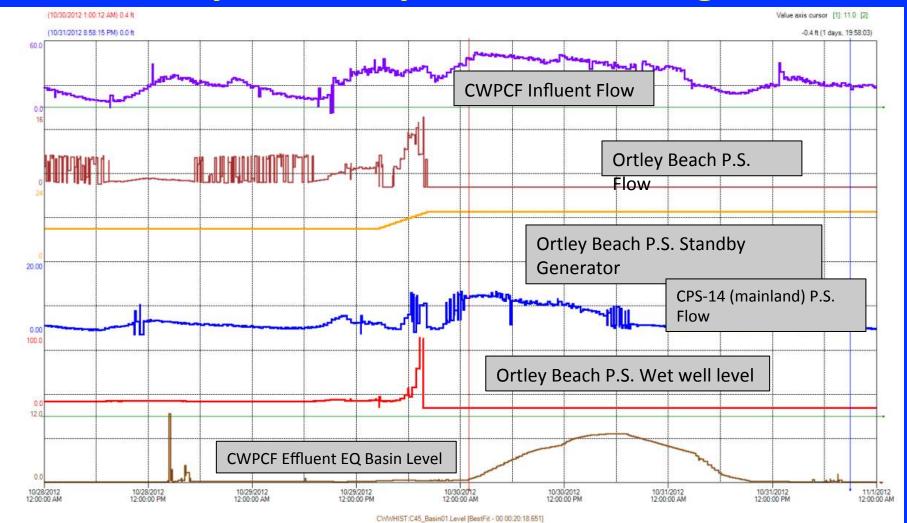
What Happened to OCUA? SCADA system analysis: 10/28 through 11/1

10/29/12, 8:00 pm: CPS-19 lost pumping capacity last recorded flow = 12 + mgd

- 10/30/12, 2:00 am:
 - CWPCF influent flows maxed at ~50 mgd
 - CWPCF Effluent EQ Basin gates opened to buffer peak influent flow

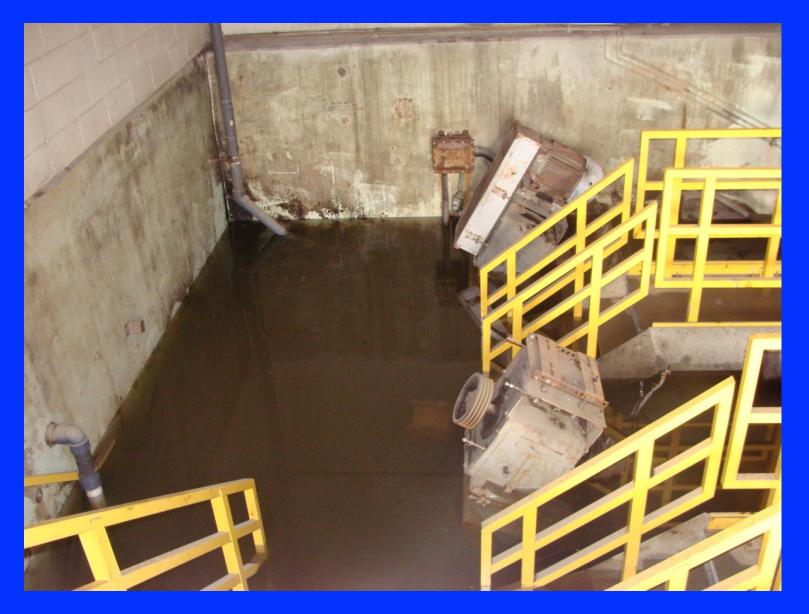
CPS-2 Lift Station, Seaside Heights

Screw Pump Motors in wet well, one removed pre-storm

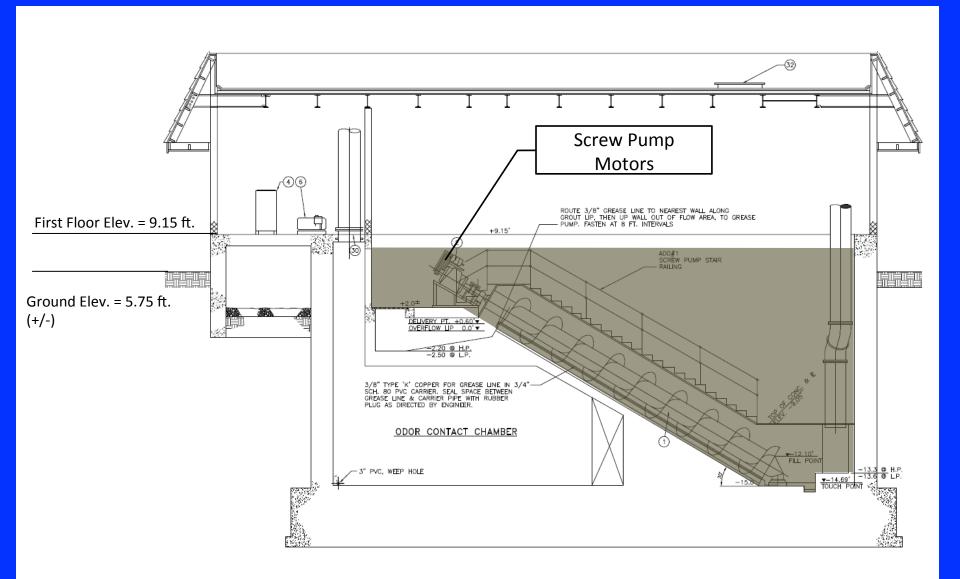
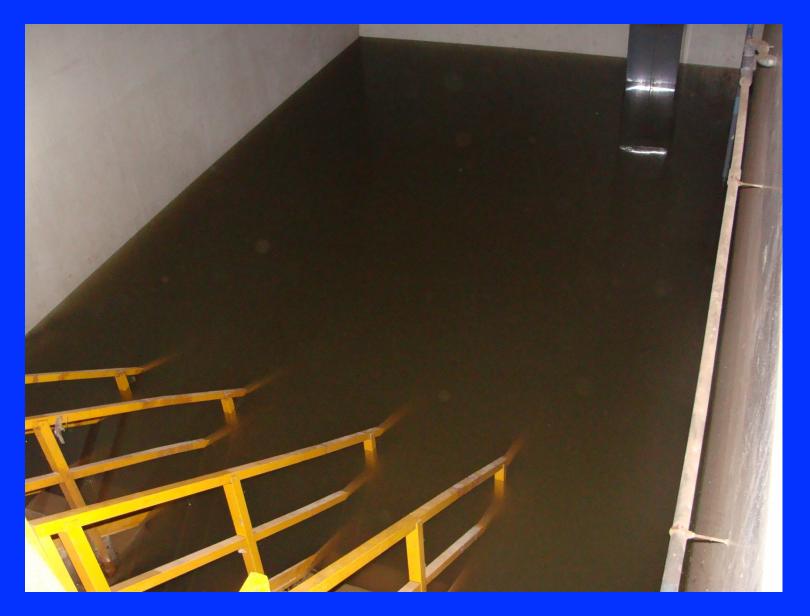
CPS-17 Lift Station, Brick Bayway - Island Region

Screw Pump wet well

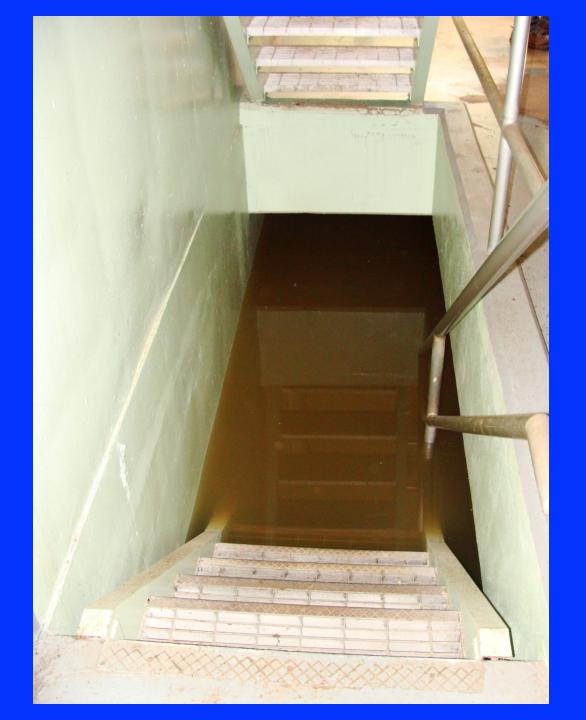
CPS-19 Pump Station, Ortley Beach

Dry Well (Pump Room) fully submerged

- Most wet wells flooded due to extreme flows, compromised collection systems
- Wet wells impacted Dry wells
 - Unsealed wall penetrations, conduits
 - Sump pump check valves
- Limited overland flow above first floor into stations
 - CPS-19 Ortley: FF elevation= 8.50 (1929 N.G.V.D.)
 - CPS-19 Dry well water level = -4.5 ft. (1929 N.G.V.D.)

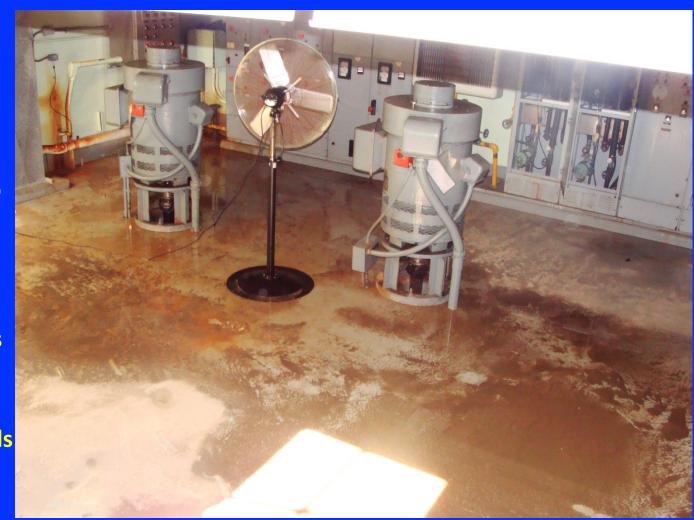
CPS-19 Pump
Station, Ortley
Beach

- Subgrade Motor Room, at sea level (+/_)
- 4 centrifugal pump motors: 100 hp -125 hp
- Motor Control Centers
- Distribution Panels
- Switchgear
- Control Panels
- Flomatcher controls

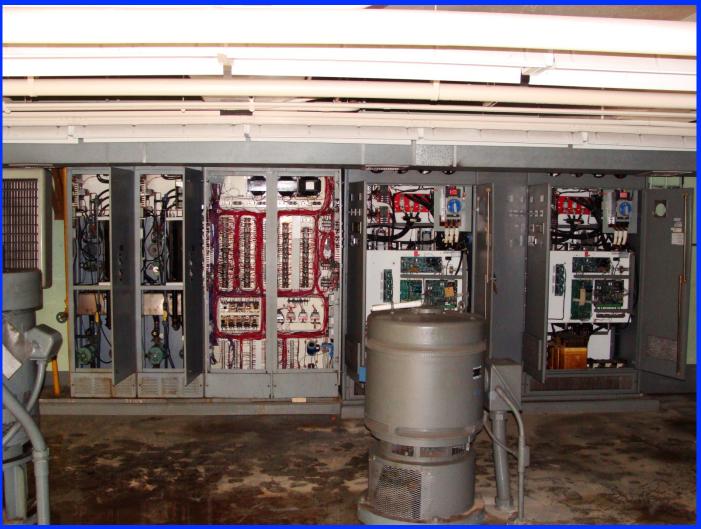
CPS-19 Pump Station, Ortley Beach

Damaged
Electrical
Control
Panels,
Breakers, etc.

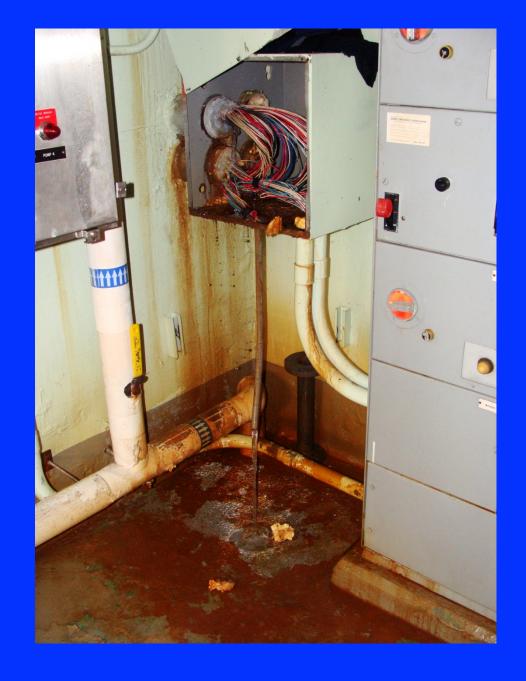
CPS-19 Pump Station, Ortley Beach

Unsealed conduits from station exterior and from upstairs generator room

sources of dry well flooding

- Procure and Install
- Major repairs contracts to be advertised
- Simple steps:
 - seal penetrations
 - closed loop radiators on roof
 - Secure loose items...
 - Check valve operation

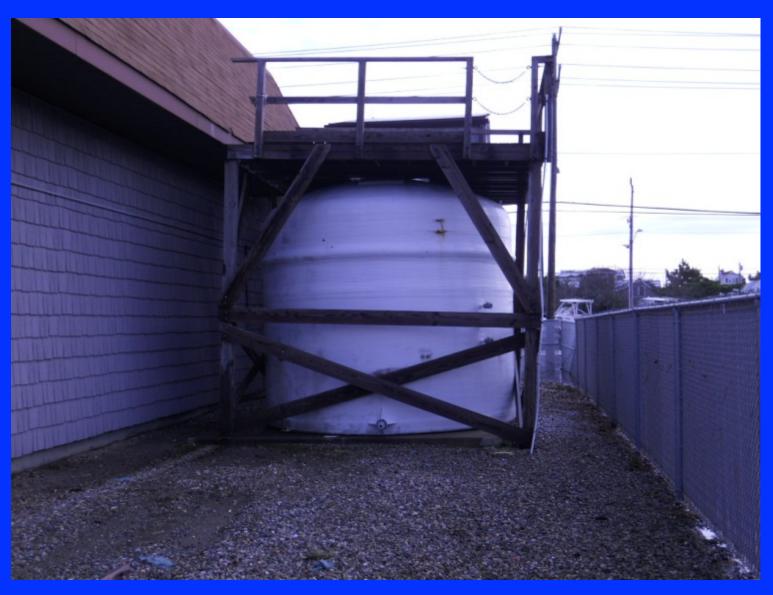
Vapor Phase GAC unit shifted
