American Academy of Environmental Engineers and Scientists Industrial Waste Management Grand Prize Award Winner

Iron Mountain Mine Sediment Removal Remediation Project

EPA Region 9

- Iron Mountain Mine Superfund Site
- Project completion: \$45 million

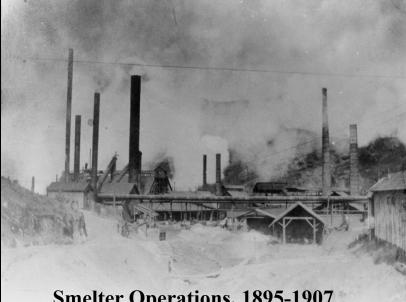
Smelter Operations, 1895-1907

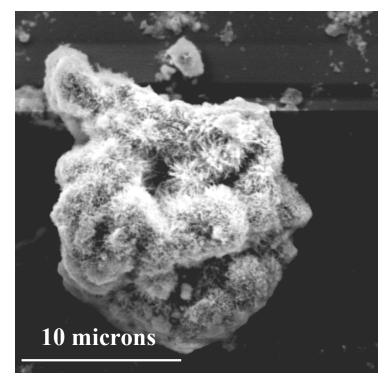
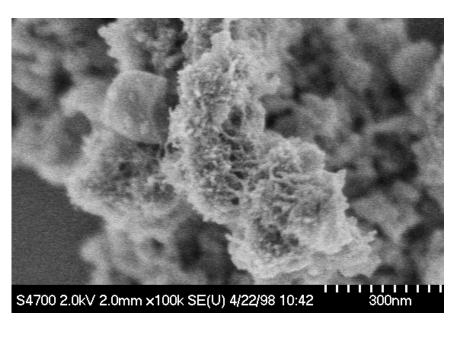
Sediment Characterization

- Fine grain size
- Large surface area: ~ 50 square meters per gram
- Sediment pore water: 100 percent mortality at 200:1 dilution

High-resolution scanning electron microscopy by J. Coston (Guarini)

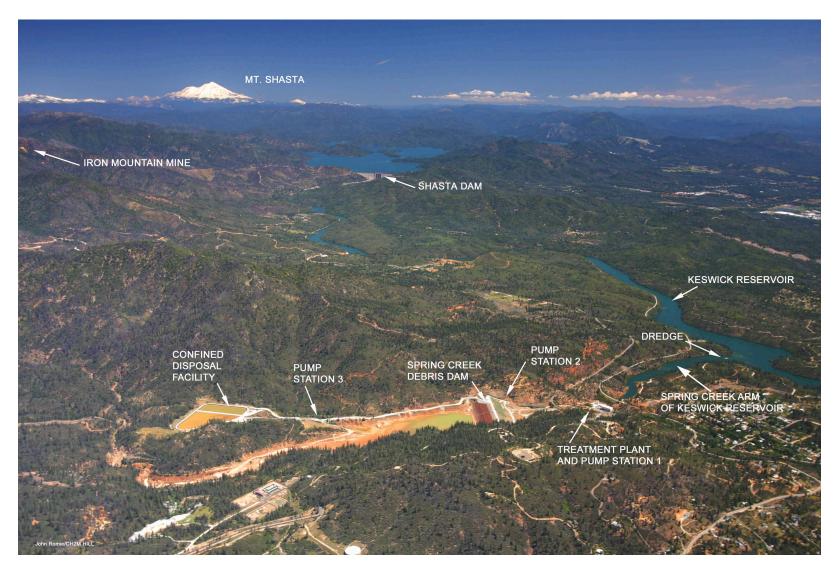
Project Elements

Chemical (lime) and Polymer Treatment

• pH adjustment and liquid/solids separation

14-inch Hydraulic Dredge

• Swinging ladder, cutter head, ~ 6,000 gpm

Pump Stations

• Three stations - 600 horsepower, electric

Sediment and Water Conveyance Pipelines

• 2 miles; elevation gain: +350 feet

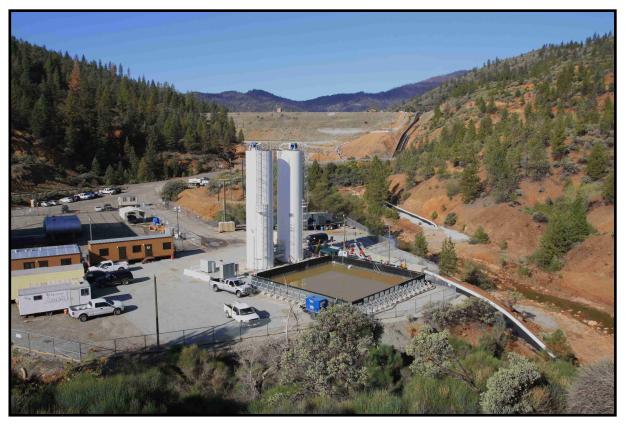
Chemical Treatment and Polymer Plants

- Chemical plant capacity: 7,000 pounds per hour
- Polymer capacity: 34 gallons per hour neat polymer

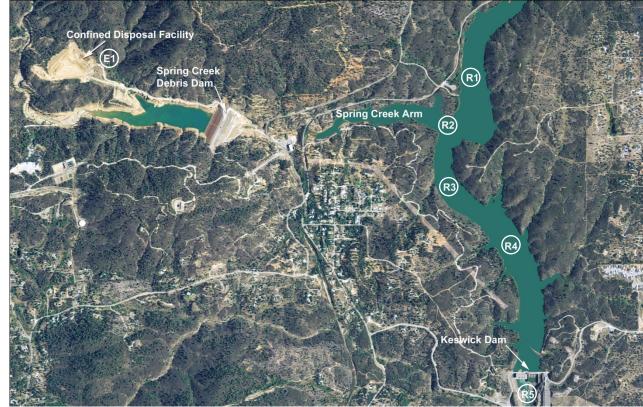
Engineering Controls

- Hydraulic dredging: 2 to 3 foot lifts
- Turbidity curtains
- Remote water quality sensors

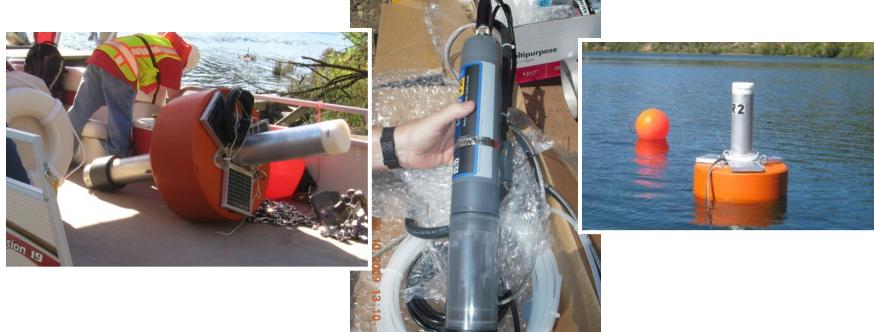
Water Quality Monitoring

YSI 6920 sondes / real-time internet transmission Turbidity, pH, temperature, DO, and conductivity Daily sampling/onsite analytical testing

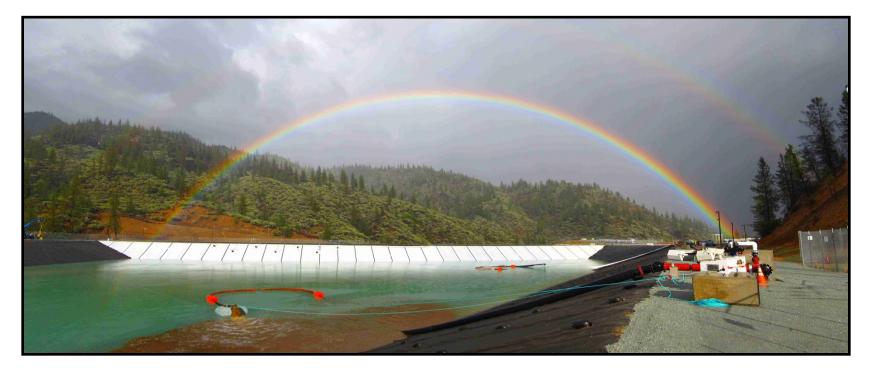
Confined Disposal Facility Operations

pH > 11

Dredged slurry 6 to 12 % solids

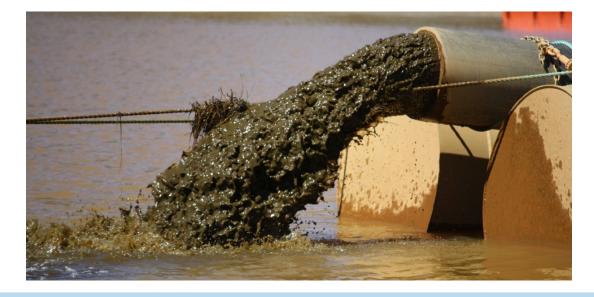
Anionic Polymers

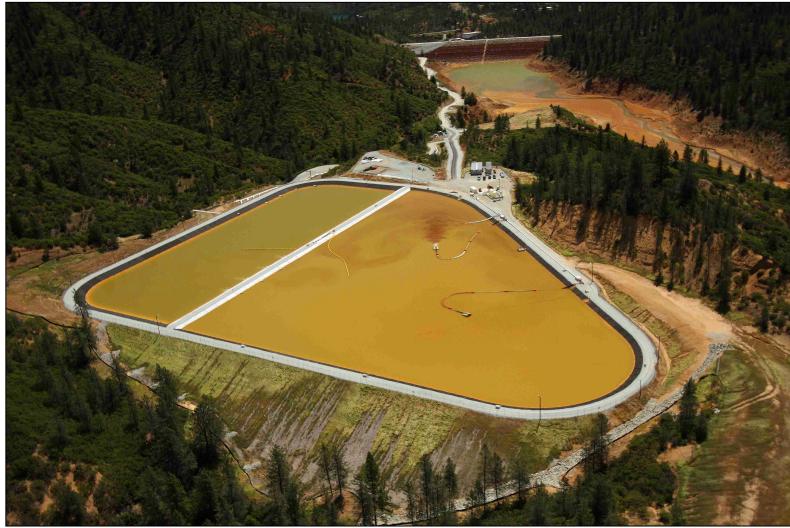
Confined Disposal Facility Dredging Complete

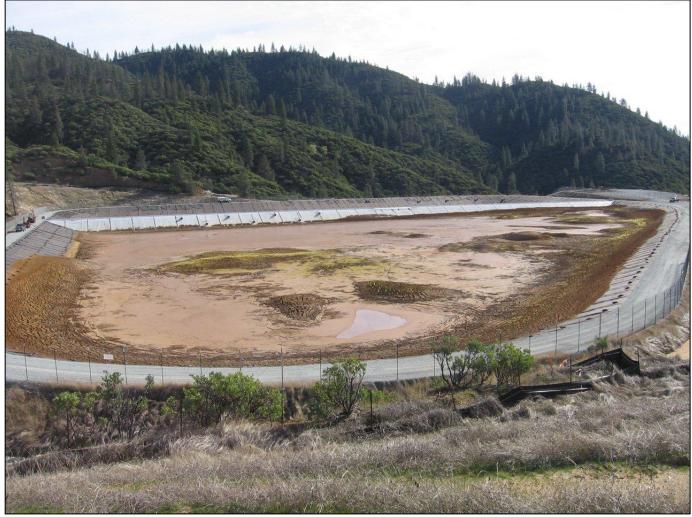
Confined Disposal Facility 10 months after dredging completed

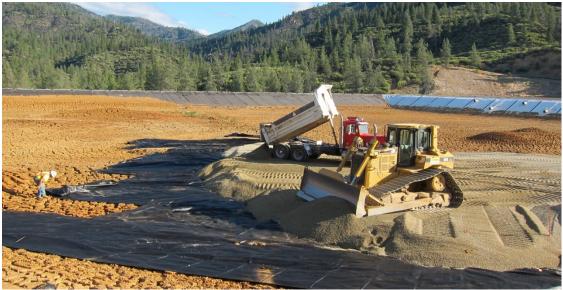
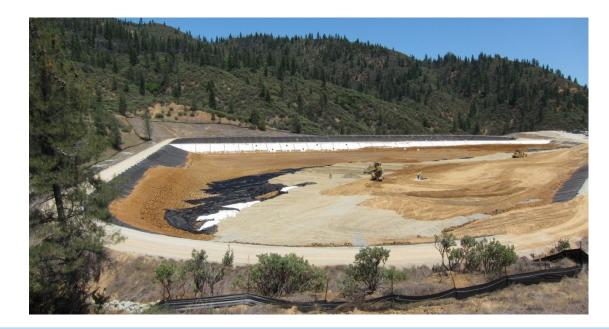
Confined Disposal Facility Closure

CDF was covered with geotextiles, granular fill, and earth fill

Geogrid placed above the geotextile in high water content/ very low strength areas.

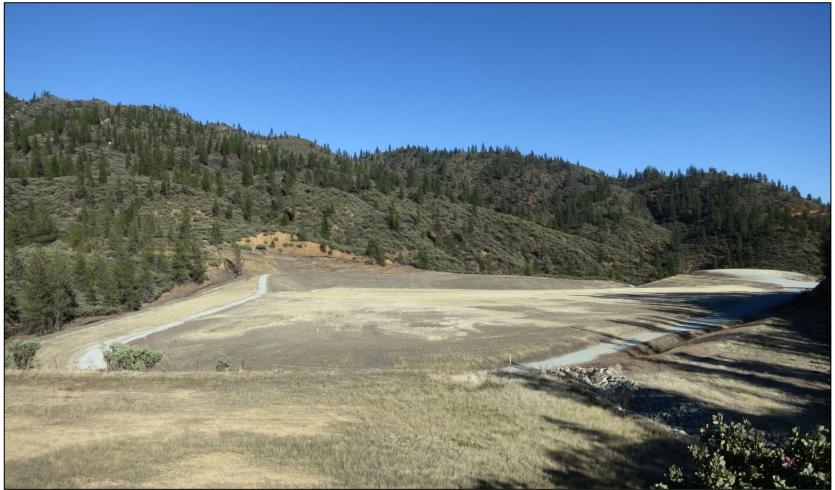
Confined Disposal Facility Grading, Liner Placement, and Revegetation Complete
