Emergency Response and Restoration of the Bay Park STP in the Aftermath of Hurricane Sandy

May 13th, 2013

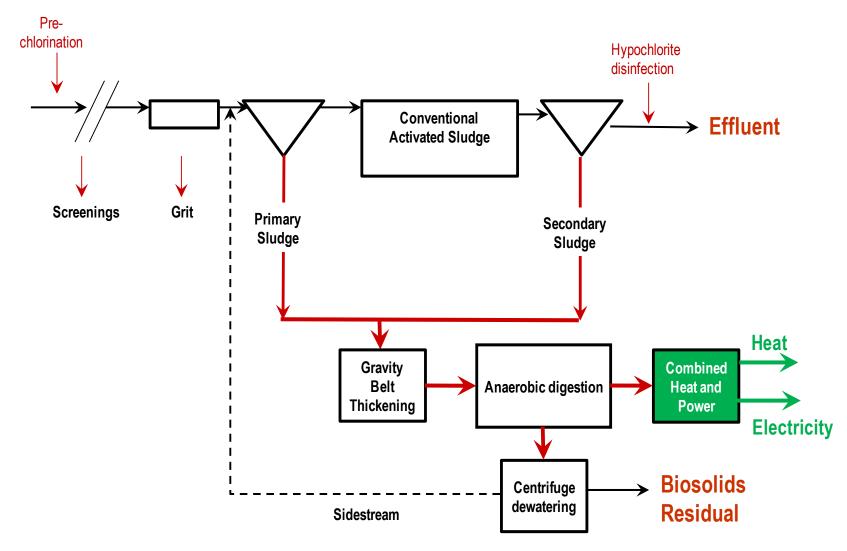
Process Flow Diagram

Bay Park STP

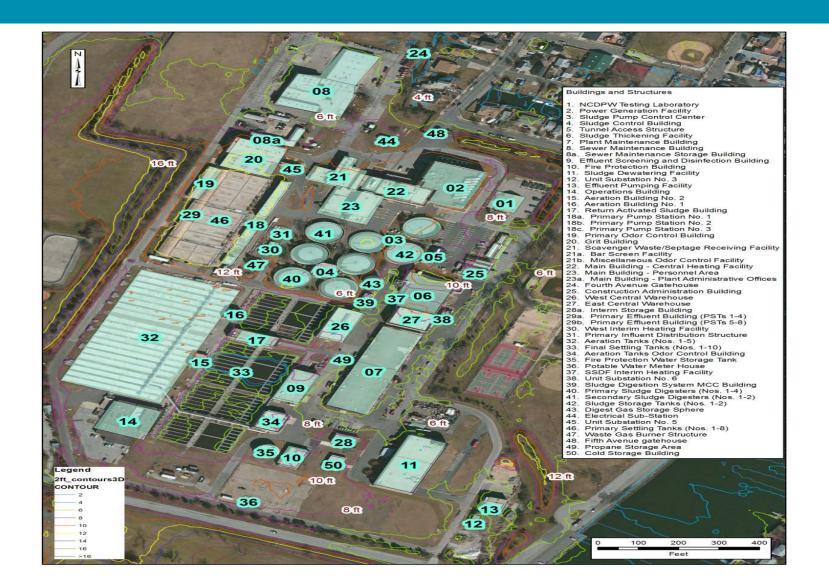
Topography & Sandy Storm Surge

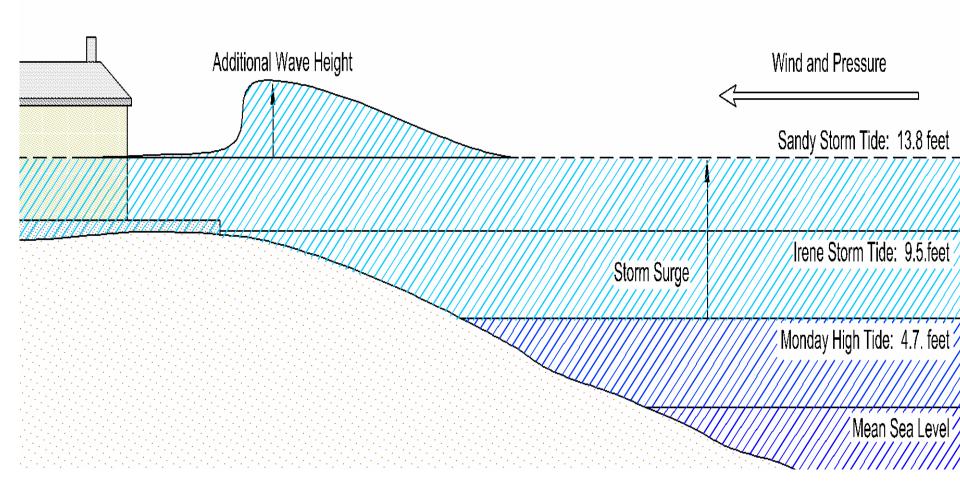
Hurricane Sandy Storm Surge

New York Battery

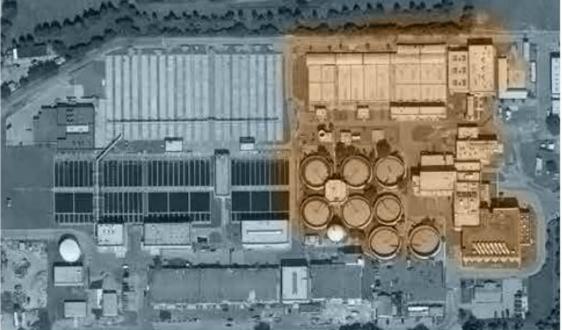
Basement and Tunnel Flooding due to Surcharged Storm and Plant Drain Systems

3 - 7 foot Tidal Surcharge above ground Elevation

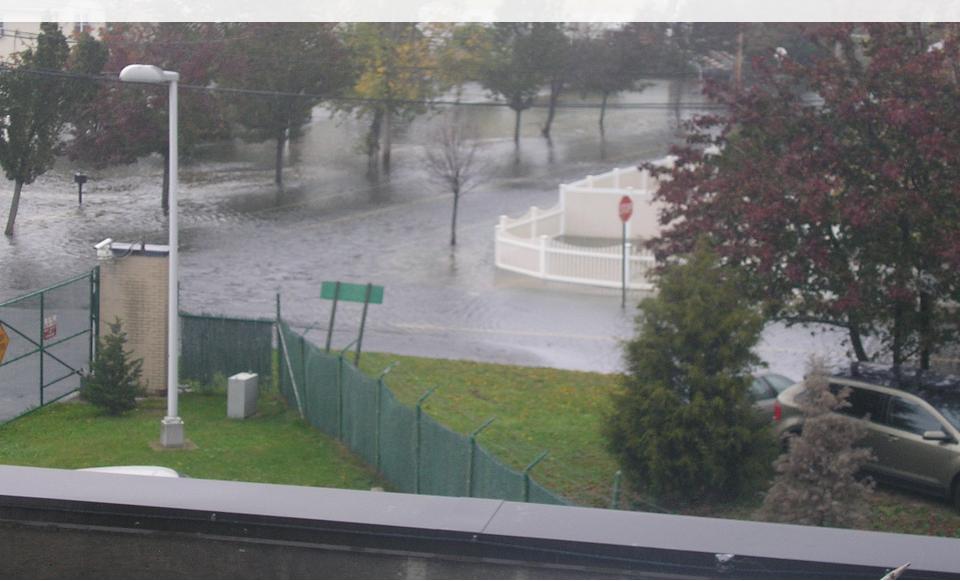
First High Tide Looking North

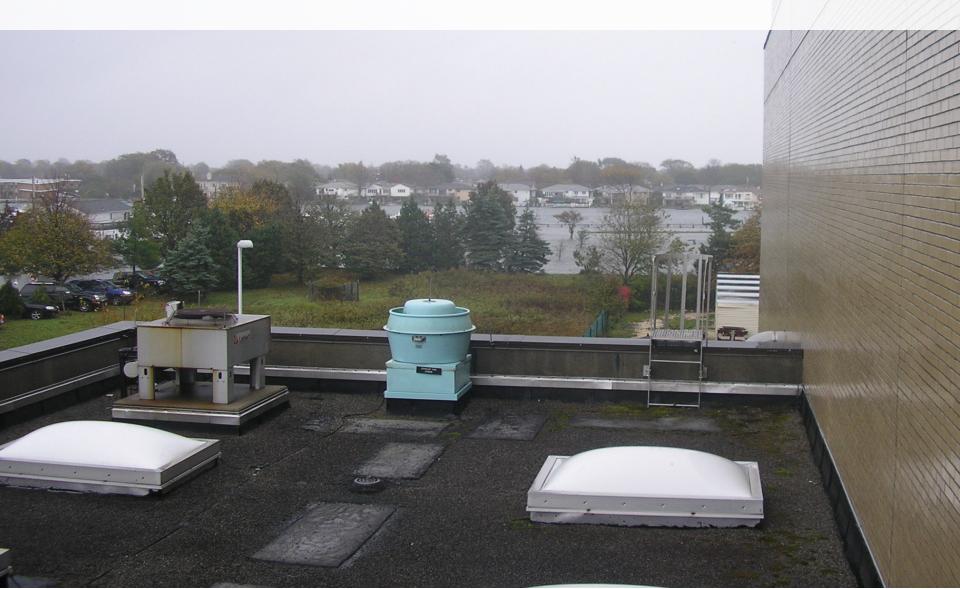
First High Tide Looking East

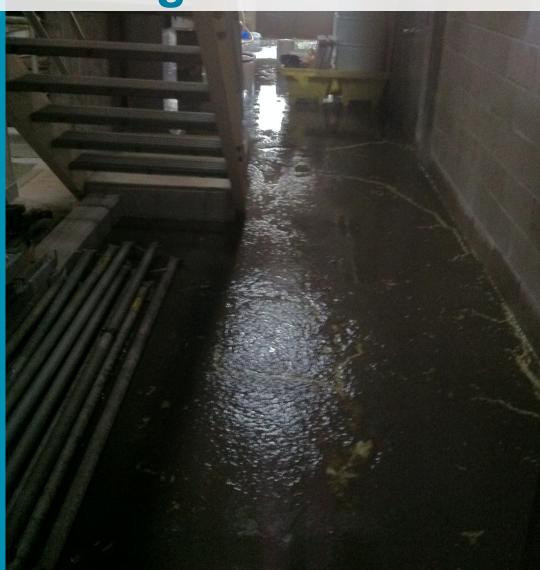
Effluent Screening & Disinfection Building

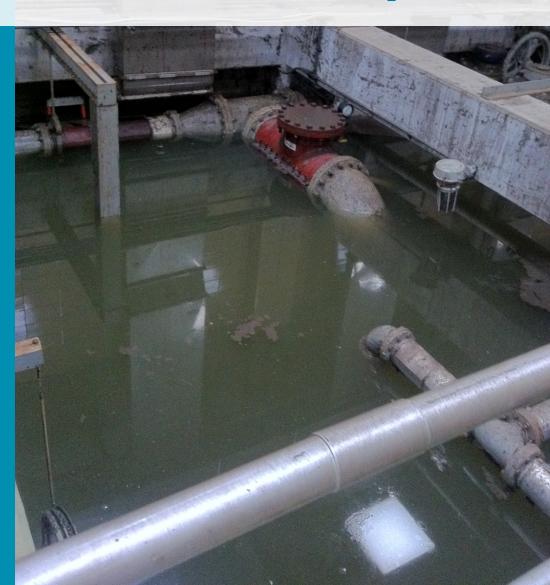
Effluent Service Water Pumps

Cooling Water for Generators

Process Water for Thickening and Dewatering

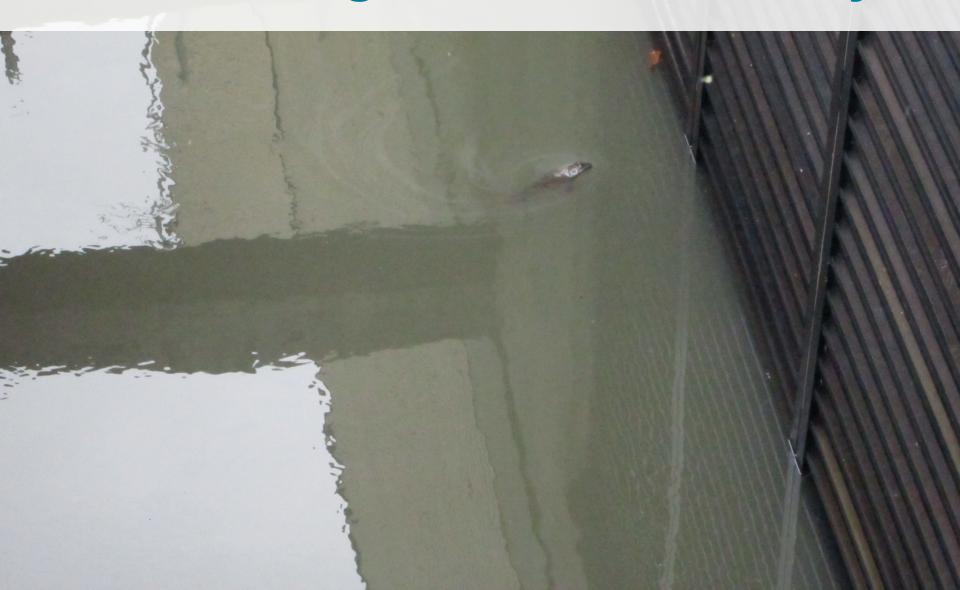
Main Building Basement Areaway

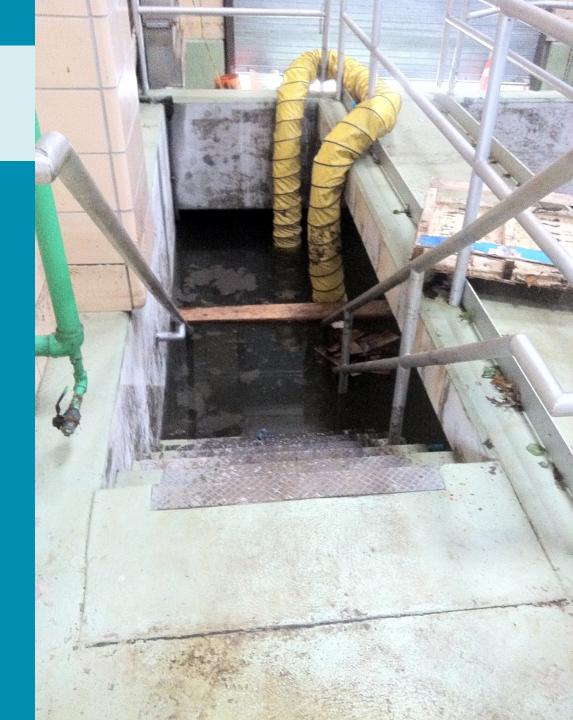
Galleries & Tunnels

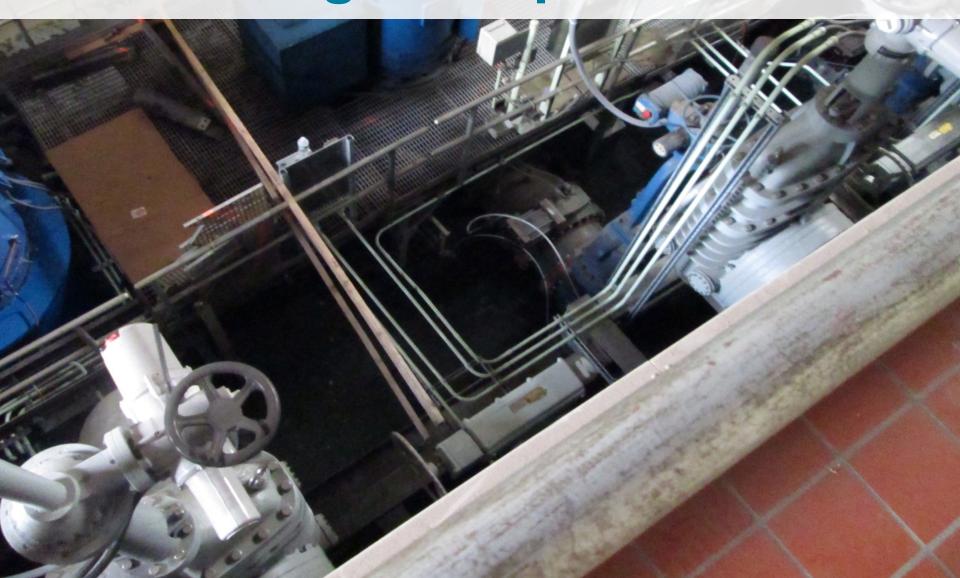
Raw Sewage Pump Station

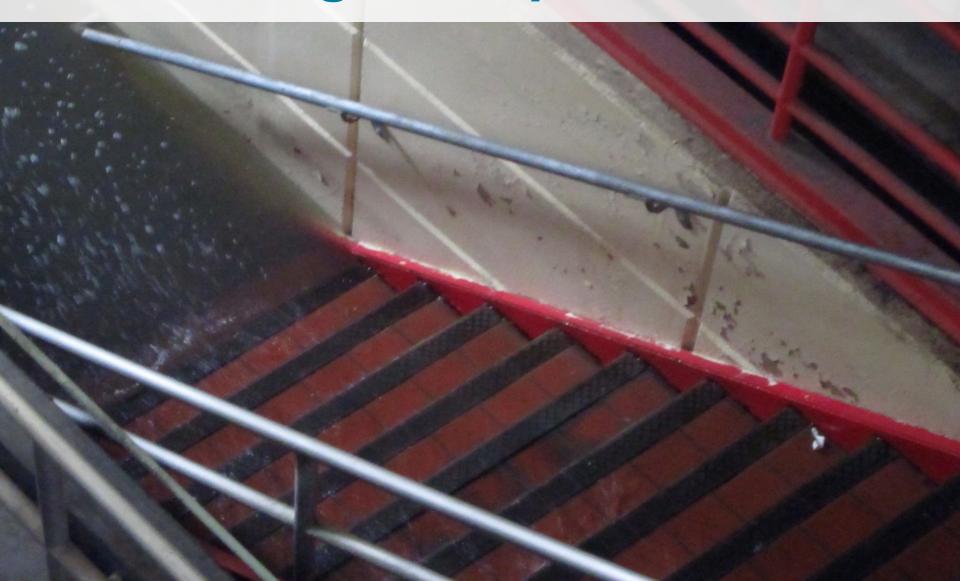
Raw Sewage Pump Station

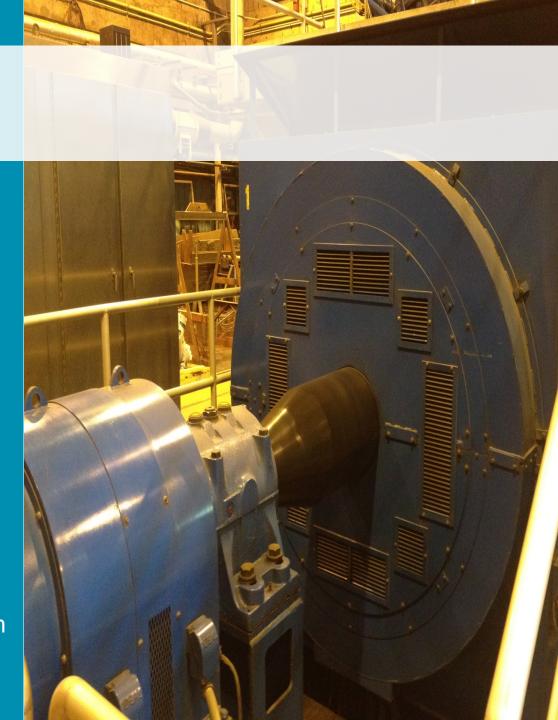
- The Bay Park STP operates its own Power Generation Facility
- Average power is 5500kW
- Four Generators rated at 3600kW, 2,400V, 3 phases, 60Hz each
- Fueled by diesel, natural gas and digester gas.
- •Power is distributed via underground duct banks through unit substations, switchgear, motor control centers (MCCs), distribution panels, and lighting panels.

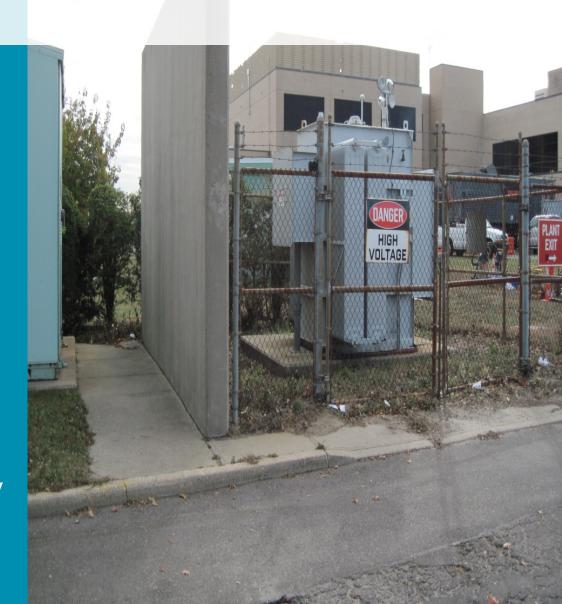
- •The Long Island Power Authority (LIPA) provides service rated at 3750kVA
- •Provides minimal standby power in the event the Power Generation Facility is not available.
- •Supplementing the LIPA service, the plant has three 1,000kW, 2400V, 60Hz diesel powered Caterpillar emergency standby generators.

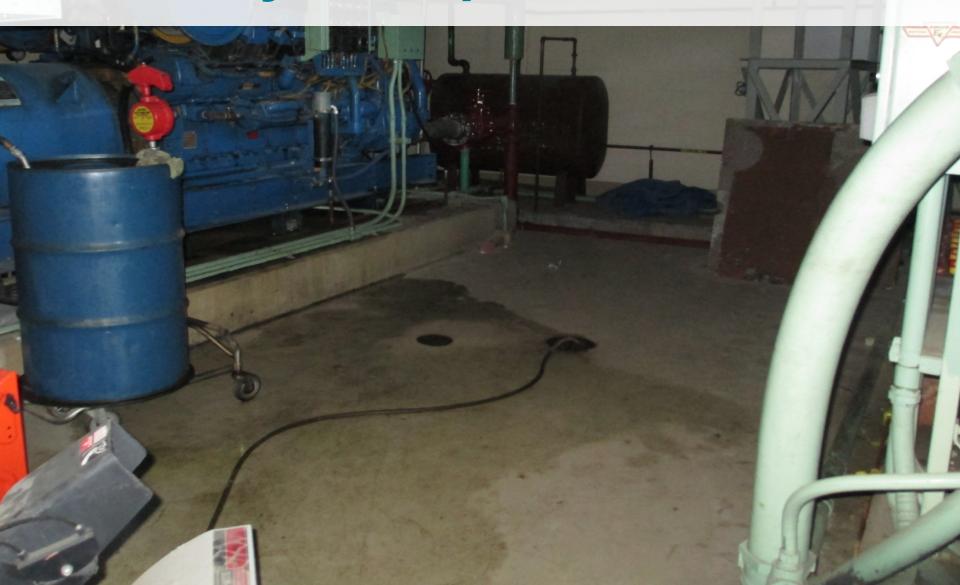
Auxiliary Caterpillars

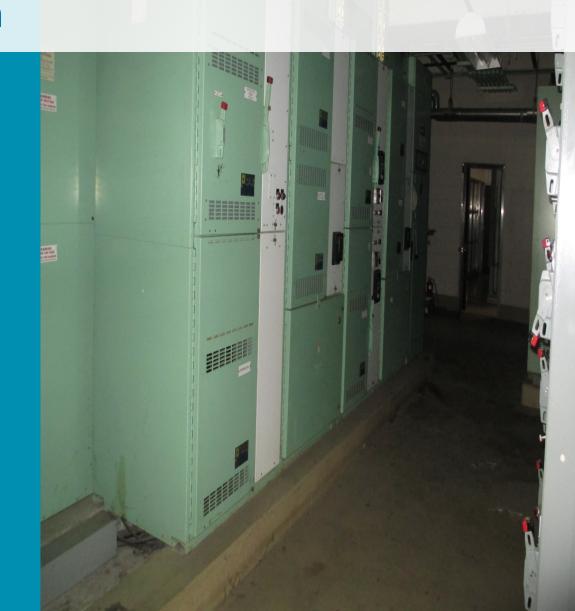
- Power Generation Facility's four main engines to the 2400V Main Switchgear.
- Power is Distributed throughout the Plant at 2400V.
- •Six (6) Unit Substations which step down the voltage to the equipment utilization voltage of 480V, 3-phase.
- 2400V Switchgear in the Operations Building - PA Blowers.

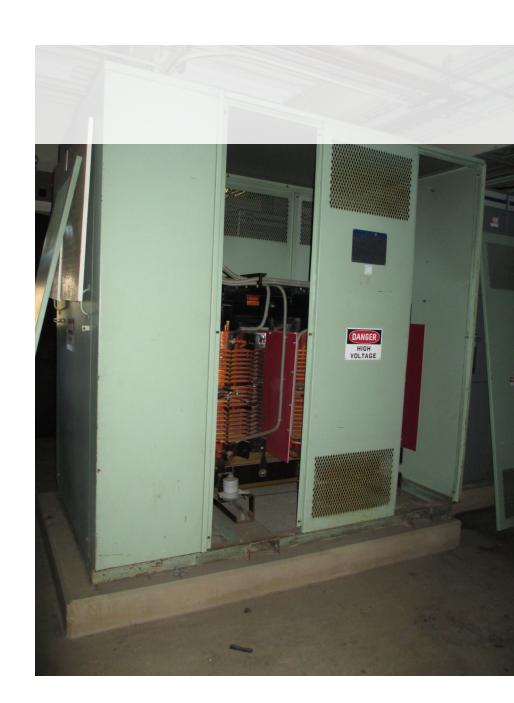
- Lower Portions of Electrical Equipment was submerged.
- Evidence of Saltwater intrusion and corrosion.
- •1600 amp Circuit Breakers
- Vertical and Grounding Bus Bars
- 120V Transformer Cooling Fans
- Lighting Transformer
- Control Panels
- Duct bank system

- De-terminated and Grounded all Power Cables
- •Implemented Stringent LOTO Procedure (1 –Key)
- Installed Necessary Temporary Systems
- Cleaned, Heated and Dried All Substations and MCCs
- •Megger Tested all Power and Control Cable
- •Bypassed Damaged Instrumentation and LCSs (Established SOPs)
- Cleaned and Baked Motors
- Purchased Replacement Motors
- •Replaced Cables or Ran Temporary Feeds

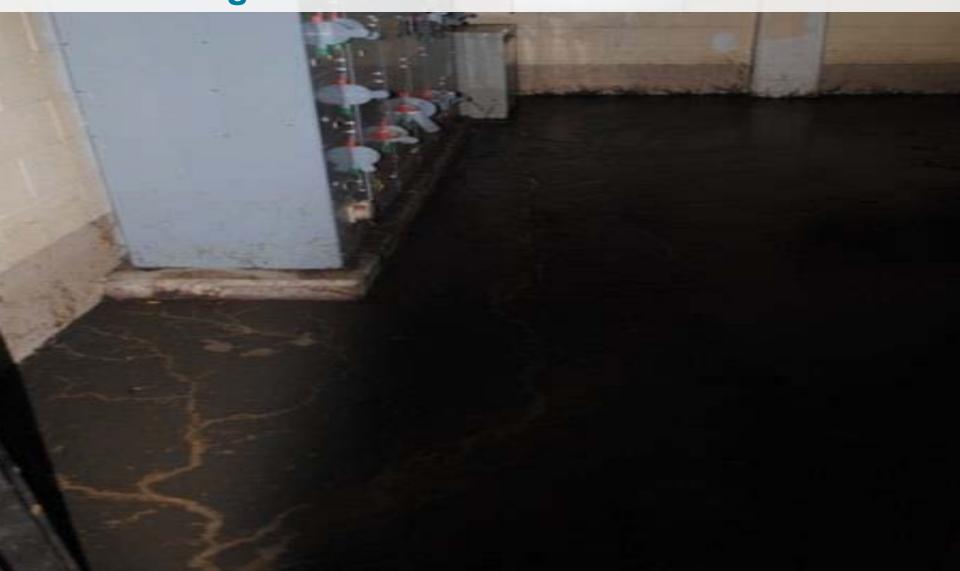
Bldg 10 MCC damaged 2.5ft Seawater

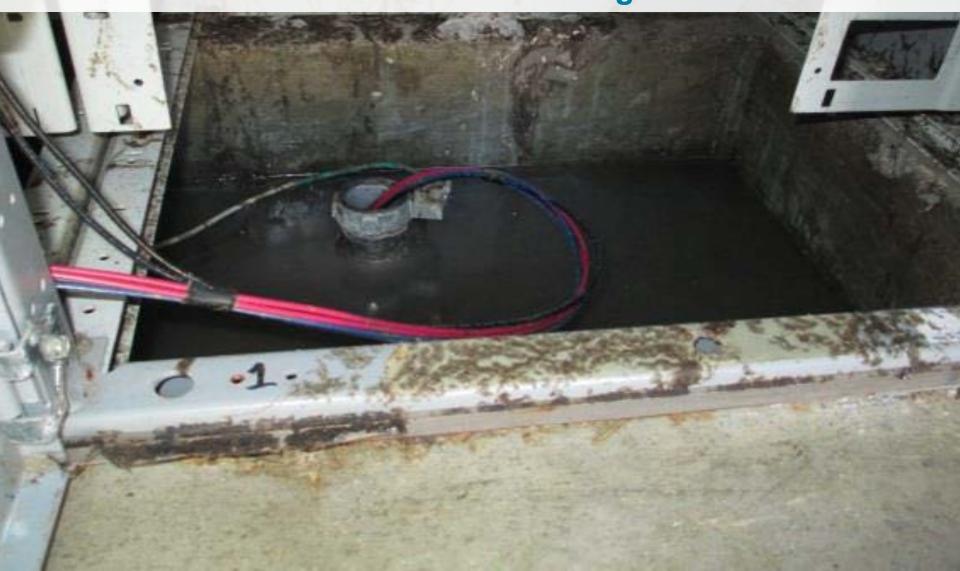
Unit Substation 4 -

Evidence of seawater infiltration through internal conduit

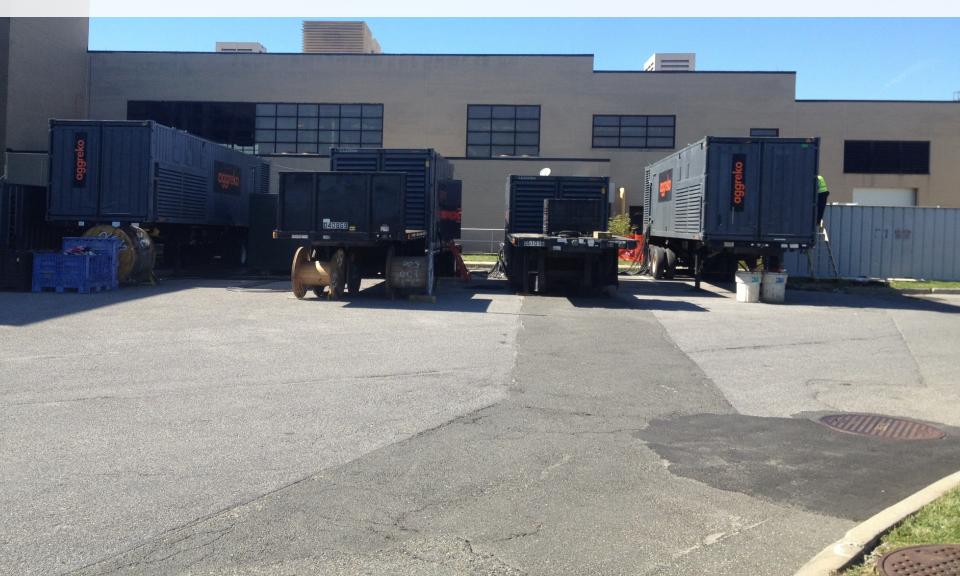
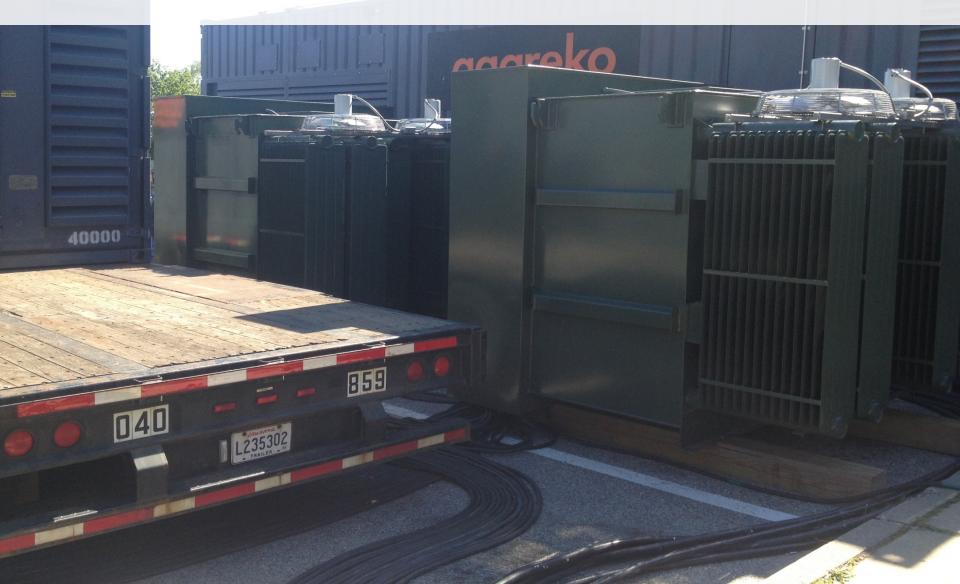
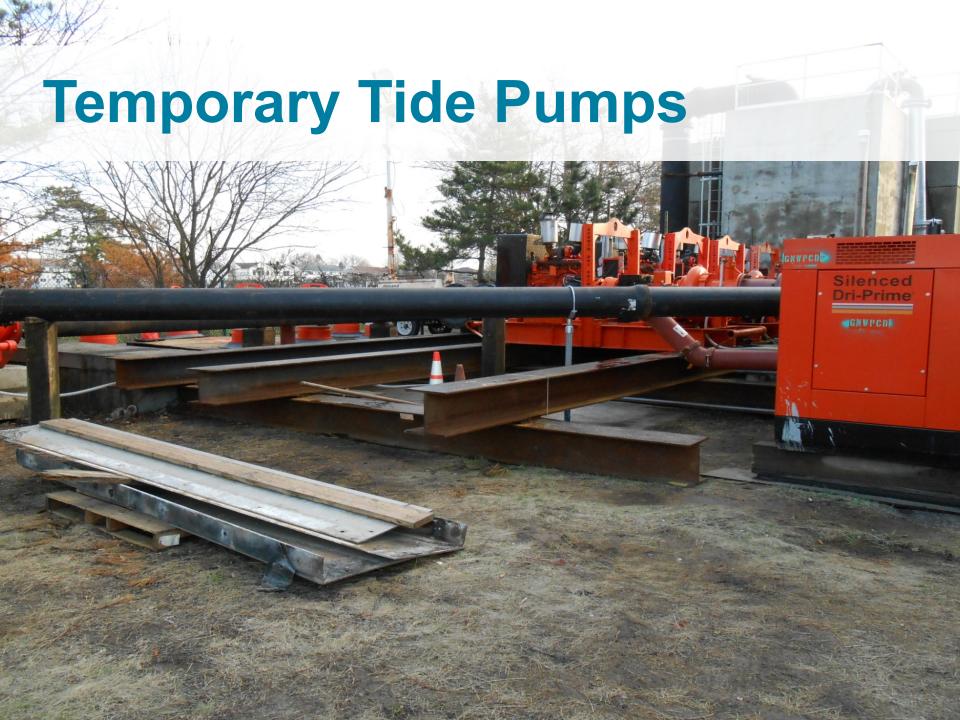
Temporary Generators
