REGIONAL WASTEWATER UTILITY RESPONSE AND RECOVERY FROM HURRICANE SANDY

OCEAN COUNTY UTILITIES AUTHORITY

Keith B. Marcoon, P.E.

The 2013 NJWEA Winter
Technology Transfer Seminar
March 4 - March 7, 2013

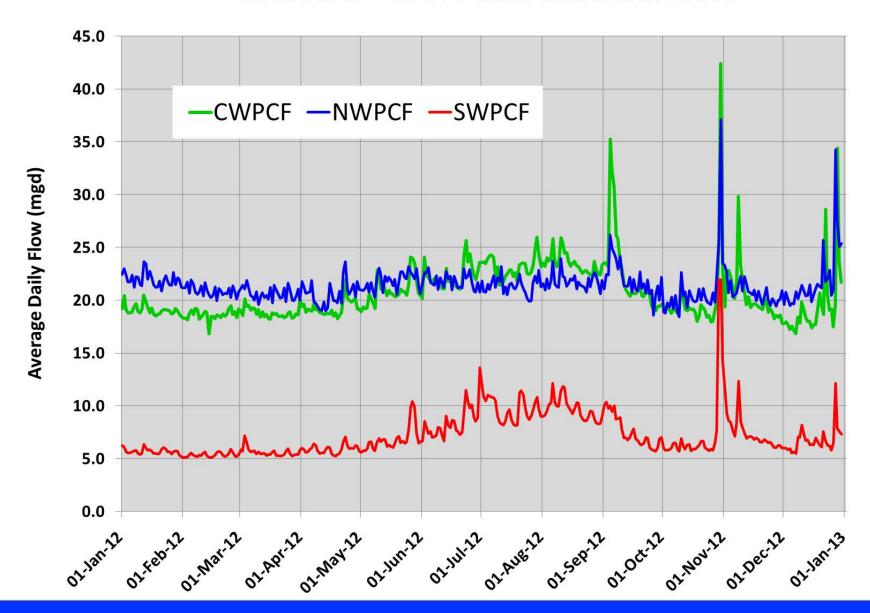
O.C.U.A. 2012 Plant Influent Flow

10/29/12, 8:00 pm: CPS-19 lost pumping capacity last recorded flow = 12 + mgd

- 10/30/12, 2:00 am:
 - CWPCF influent flows maxed at ~50 mgd
 - CWPCF Effluent EQ Basin gates opened to buffer peak influent flow

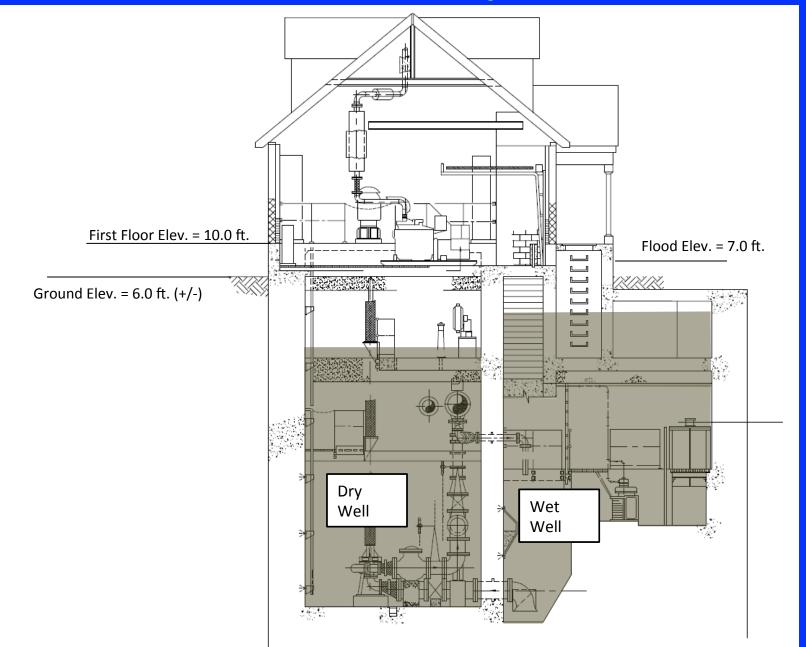
CPS-1 Lavallette Pump Station

Damaged Equipment
